# IMPORTANT PRODUCT INSPECTION NOTICE - NRG-200-N ROPE GRAB (RG-08)

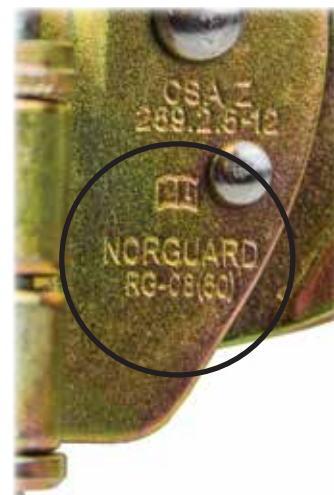
Affected product will be marked with the following: **Norguard RG-08**. Only Rope Grabs provided by Norguard are potentially affected; no Guardian Fall Protection Rope Grabs are at risk of this defect.

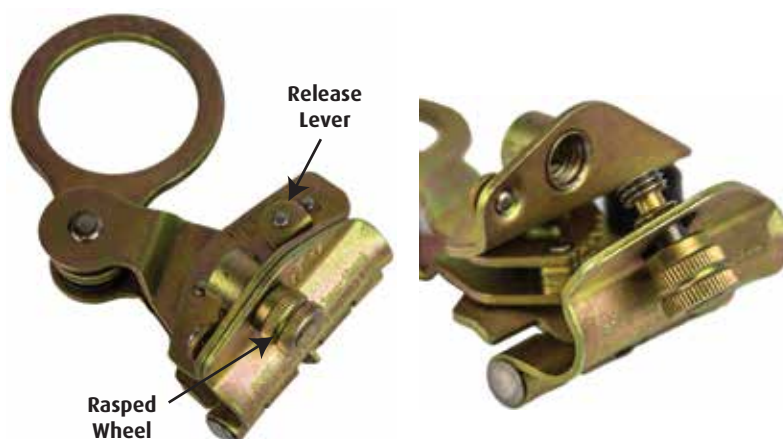
OK

2. Continuing to turn, the rasped wheel should meet a point of resistance, at which point the release lever must be engaged to continue turning. If Rope Grab functions in this manner, and if rasped wheel is not able to be removed from locking screw with further turning, the product is NOT defective.

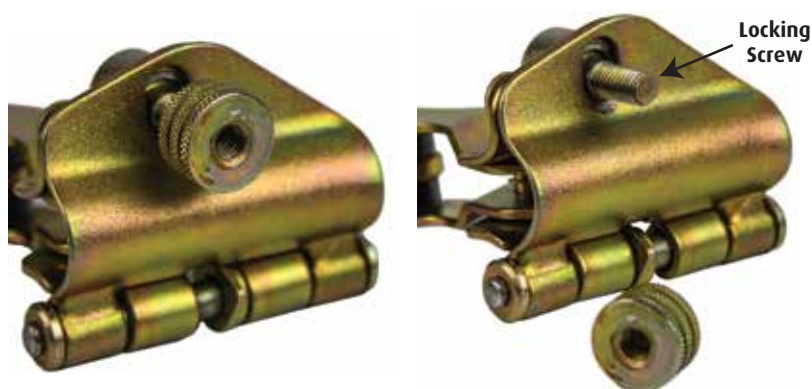
NO

For affected parts, the rasped wheel component is able to be fully removed from the locking screw. Please note that Norguard has conducted extensive testing of affected samples and determined they function safely when properly installed and present no risk of accidental detachment when in use, however the rasped wheel is not intended to be removable and consequently merits this inspection notice.

3. If rasped wheel can be turned without engaging the release lever and can be fully removed from locking screw, the product IS defective and should be removed from service.

If you find that you have a defective unit, immediately remove product from service and contact Norguard for return or replacement. DO NOT attempt to repair fall protection equipment under any circumstances.
